**Beaver Dam - White River, Arkansas**

# **Beaver Dam Secant Pile Wall Completion Report**

**OCTOBER 1995**

3. REPORT TITLE BEAVER DAM SECANT PILE WALL COMPLETION REPORT . . . VOLUME 1		2b. GROUP
4. DESCRIPTIVE NOTES (Type of report and inclusive dates) FINAL CONSTRUCTION COMPLETION REPORT

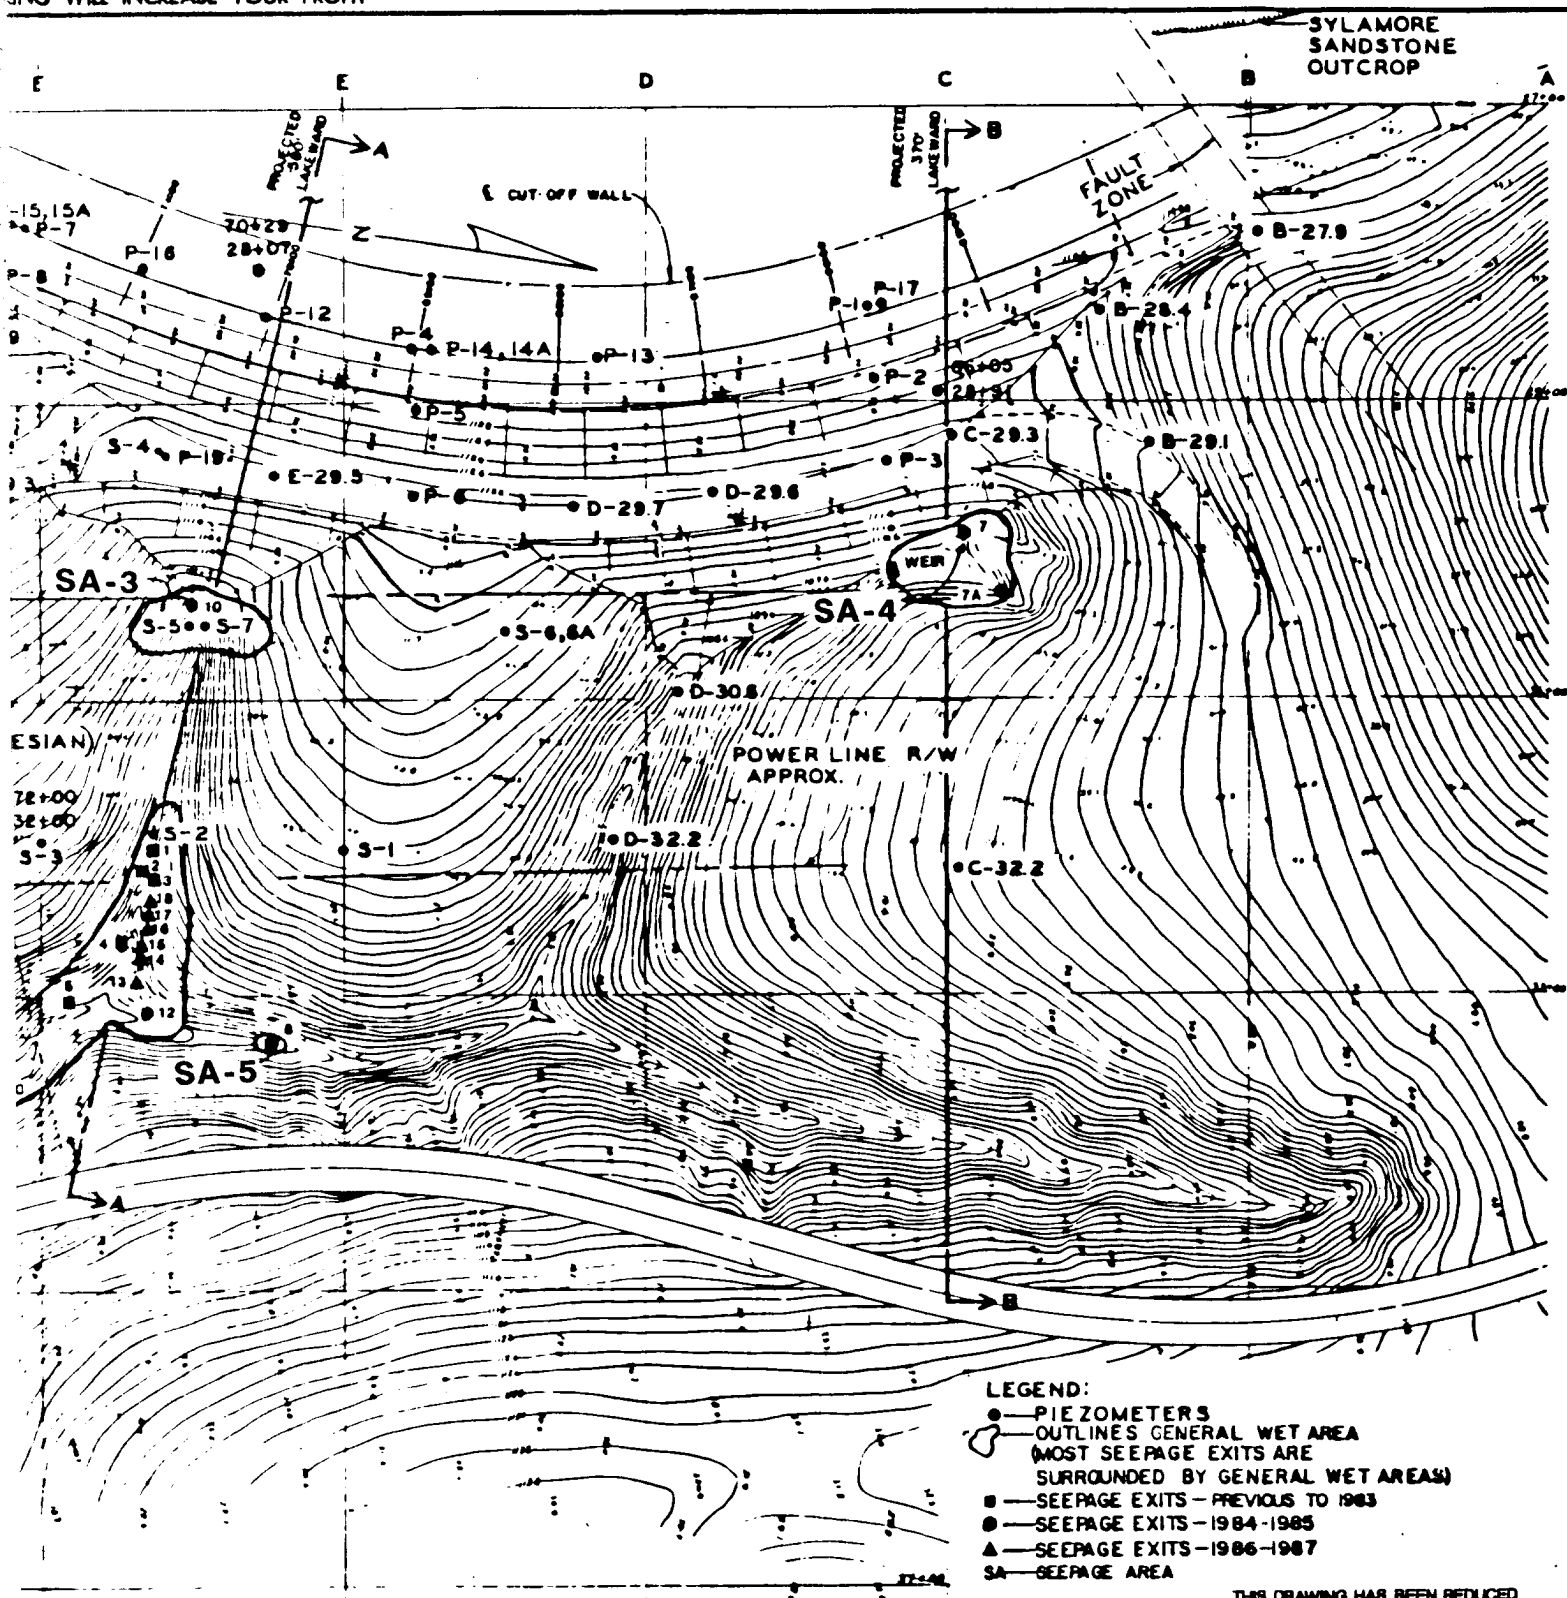
Shortly after construction and during the initial reservoir filling (1966) against Dike 1, seepage was detected from 5 areas (Plate A-6) downstream of the dike, totaling approximately 800 gpm at normal lake level. To monitor the seepage flows, a temporary weir was installed below seepage Exits 1, 2, and 3 in 1966. A permanent Parshall Flume, referred to as Flume No. 1, was installed in 1967 to intercept all flow from known seepage exits. Twenty six piezometers were installed between 1968 and 1972 to monitor seepage conditions in overburden, weathered rock, and sound rock. Remedial grouting, performed intermittently between 1968 and 1971, reduced observable flows to about 500 gpm at normal lake level. Plate A-12 shows the approximate depth of the grout curtain. It was pointed out in the geological analysis of the Dike 1 Remedial Foundation Treatment Report (1972) that due to the characteristics of the Boone Formation, i.e., numerous open and clay filled cavities, channels, porous (sponge like) rock, with deep, intensely weathered, pervious zones in the foundation and fault areas, that grouting would not solve the seepage problem.

By early 1975, a seep at Exit 6 and a small wet area at Exit 7 were observed (Plate A-6). Seepage at Exit 6 continued to grow until by 1982 a major seepage exit had developed (10 Gal/Min flow). Seepage in Exit 7 remained the same until the pool of record in December 1984 (el. 1130.4). Seepage Exit 9 was also discovered about that time and was found to have muddy flows. Exit 9 lies almost 500 feet downstream of the Dike 1 toe. On 2 January 1985 (pool el. 1125.1) seepage was observed jetting approximately 1.25 inches vertically and producing about 6 gpm at
